PS-2252-12-TP1 Net Forward Encoder Interface

The PS-2252-12-TP1 Net Forward Encoder Interface (NFEI) accepts inputs from the A and B channels of a standard quadrature encoder. The NFEI outputs a pulse for each forward direction transition of the encoder, but reverse direction transitions result in no pulses. Furthermore, following reverse movement, no output pulses result from forward movement until the encoder position exceeds the furthestmost forward position reached before the reverse movement. The NFEI rejects jitter resulting from mechanical oscillation at a transition point of the encoder with the system at a zero average velocity. Note: If more than 65,535 consecutive reverse encoder transitions are made, an Overflow output on the NFEI is activated indicating that the reverse counter has lost track of reverse transitions. A reset input allows clearing the reverse counter in order to restart.

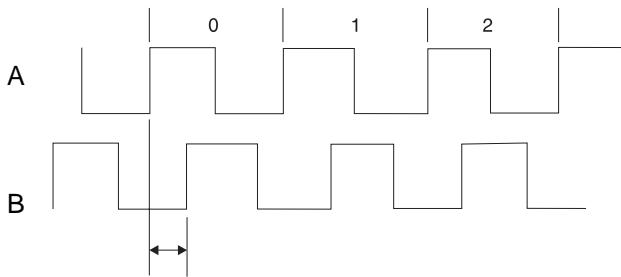
Mechanical oscillation of the encoder is properly tracked by the NFEI as long as the minimum time between encoder channel edges is within specification, as illustrated below.

17 microseconds minimum

- Verify that the voltage on the + and - terminals of the NFEI terminal block is between 11 and 15 VDC.
- Verify with oscilloscope that proper encoder signals (per Internal Encoder Count illustration) are present at the Chn A and Chn B terminals of the NFEI terminal block, and that the voltage levels are TTL compatible (logic 0 less than 0.8 v and logic 1 greater than 2.0 v). If not, there is a problem with the encoder or encoder cable. If the encoder signals are proper, the problem is internal to the NFEI, and the NFEI should be exchanged.

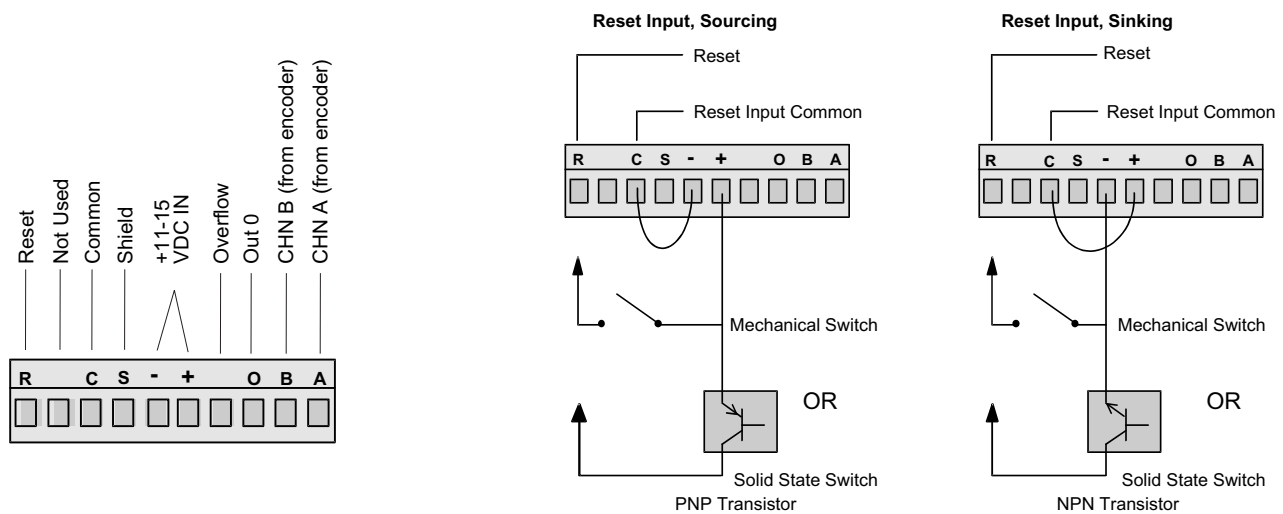
Connect the NFEI using the Terminal Block Wiring illustration below.
